ALTA VISTA
AT BALLSTON METRO CENTER

REPLACEMENT RESERVE STUDY
2007

RE: ALTA VISTA CONDOMINIUM
Replacement Reserve Report

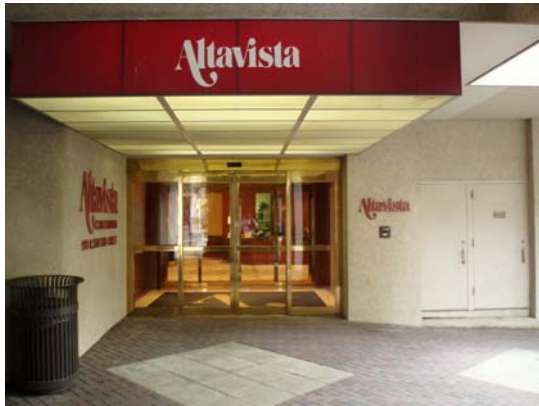
The lobby was renovated in 2002 for the third time since its original construction. Both sets of automatic sliding glass doors were replaced then. The marble flooring is professionally maintained and should last two to three renovation cycles. Lobby renovations are scheduled every 15 years (see photos #1, 2, and 48).

Photo 1. Entrance w/canopy

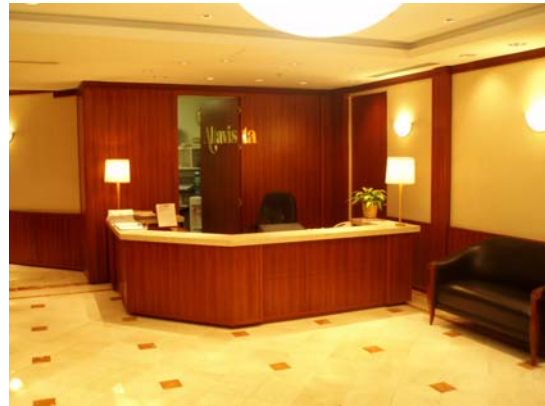
Photo 2. Reception/Security Desk

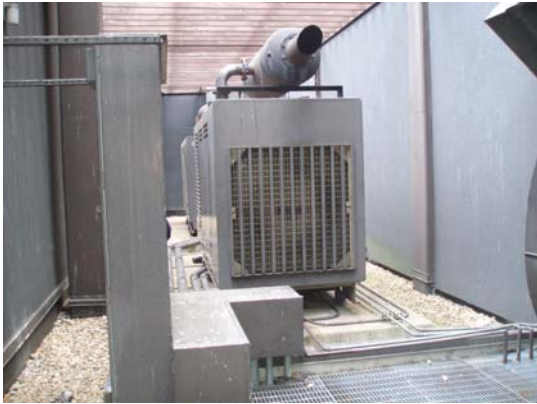
Emergency Generator. The emergency generator was installed in 1989 and is exercised weekly. The generator is reportedly in good working order and is scheduled for replacement in the next 8 to 10 years. The generator has two 1/3-hp original pumps and a 300-gallon diesel fuel tank. When in use the building does not draw the optimal 80 percent of the 450 Kva according to the building engineer. At the time of replacement an electrical engineer should review the generator capacity and recommend a size that is better suited for the needs of AltaVista Condominiums. The generator replacement cost includes related design fees. The existing system is professionally maintained and maintained regularly. (See photos #7 to 10).

Photo 7. Generator

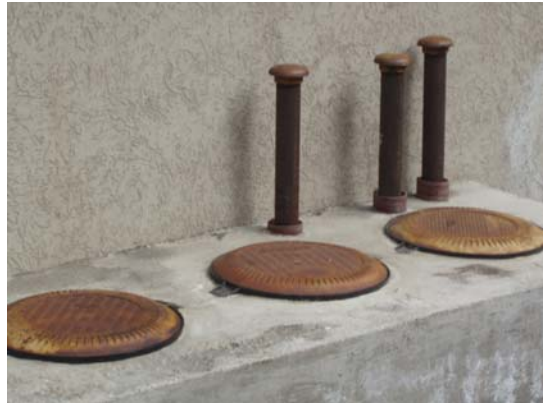
Photo 8. Fuel Fill Caps

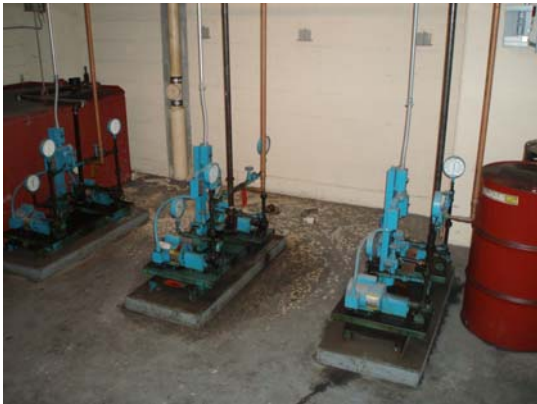
Photo 9. Fuel Pups

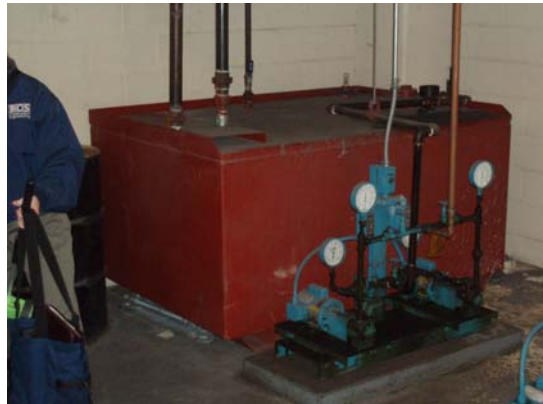
Photo 10. Fuel Tank

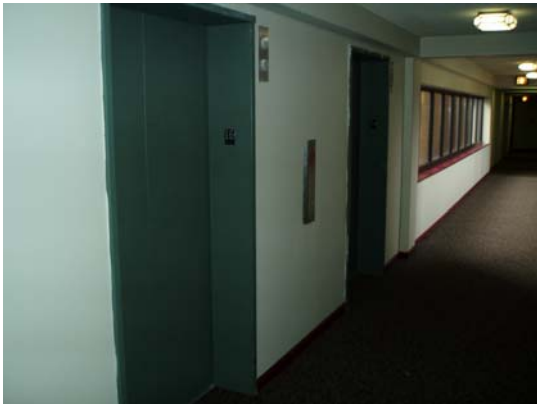
Elevators. The three elevators are functioning and reportedly in good working order. The reserve study includes replacement at the end of a 29-year useful life. The elevators are a 3,000 lb capacity, traction system. The replacement includes elevator machinery, controls, cabs, and doors (see photos #15 to 18).

Photo 15. Elevator Doors

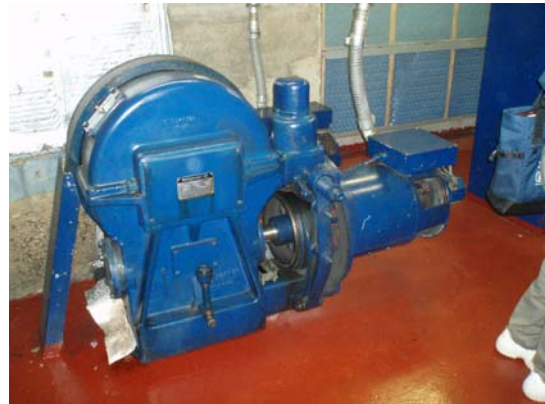
Photo 16. Elevator Motor and hoist

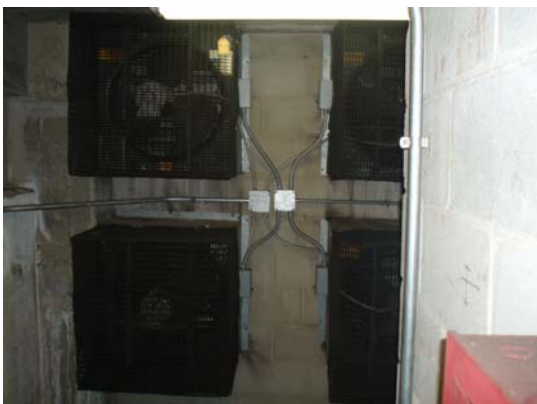
Photo 17. Elevator Exhaust Fans

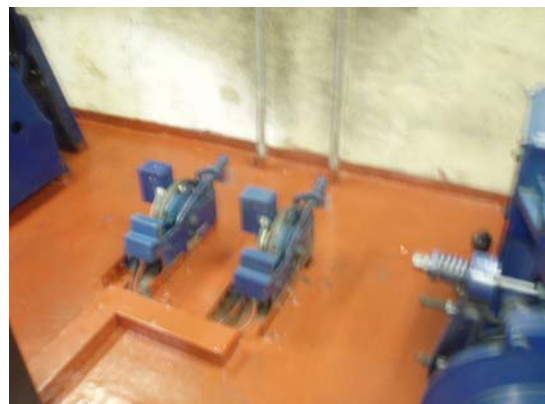
Photo 18. Elevator Hoist

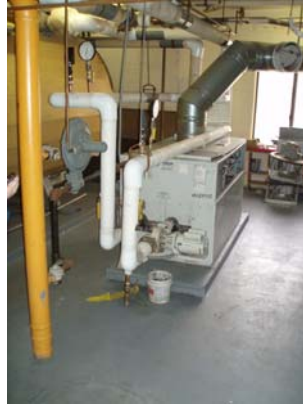
Boilers. The existing boilers were built by Lochinvar and have been in service approximately 7 years (see photos #20 and 21). The boilers have a new regulator and new main water shut-off, and the building engineer reported that minor replacements and preventive maintenance is continually performed on the system. These gas-fired units provide hot water for domestic use. There are two hot water tanks to accompany the boilers. One boiler with a 2,500 gallon storage tank serves floors 8 through 20. The second boiler with a 1,500 gallon storage tank serves floors 21 through 26. The tanks are from the original construction and are dated 1988 (see photo #19). The Association intends to test the tanks in several years to determine the wall thickness to establish the remaining service life, which could range from three to 20 years depending on the material of the tank lining. The cost of the storage tank replacement used in the study includes crane mobilization and masonry demolition to provide an opening in the wall to fit the tanks. The boilers should be able to be hoisted using the elevators, and the replacement cost includes a related design fee.

Photo 20. Boiler

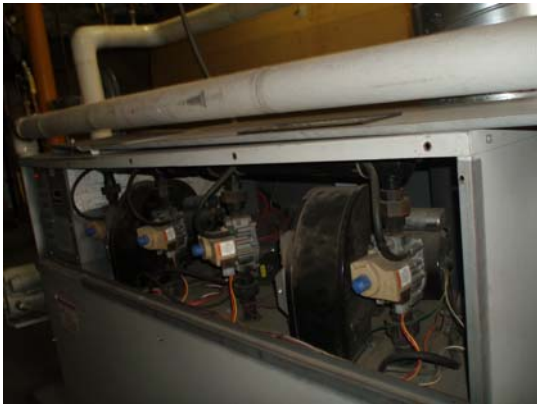
Photo 21. Boiler up close

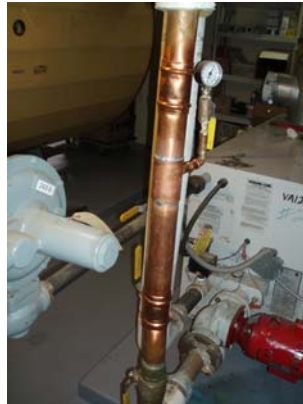
Building Piping Systems (excluding Heating and Cooling). The Association owns the piping from the public utility connection point to the wall of each condominium unit (see photo #22). The copper supply pipes had a history of developing pinhole leaks until recently when the Association implemented a policy to turn off the building's water only one time per month. Since then, the occurrence of pinhole leaks has reportedly been minimal. This practice should help to extend the life of the pipes and valves. A valve study was done several years ago, with a determination that there are a lot of valves and they were not exercised for long periods of time, and therefore may not work when exercised. The Board received a cost estimate to replace all of the valves and determined that it was too expensive to do so. The cost to replace the various risers for rainwater and utilities throughout the building were estimated using data from R.S. Means Building Construction Cost Data and our experience with similar properties. Because it is very unlikely that all of the components of these systems will require replacement within the thirty year period of the

study, we have included funds to replace 40% of the pipes over a 45- to 50-year period. The valve replacements are part of the supply piping cost.

Photo 22. Piping

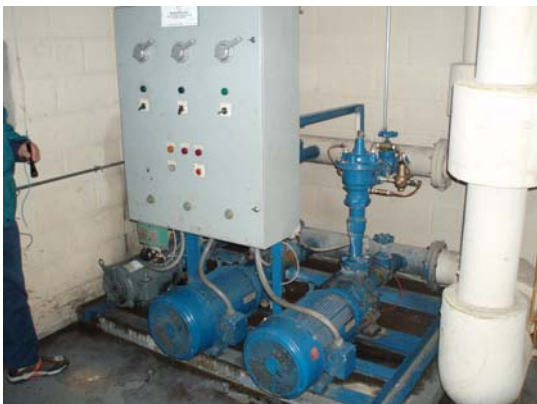
Domestic Water Booster Pump. (See photos #23 and 24). Three domestic water booster pumps are used to pump the supply water throughout the building. One of the pumps has a 10-hp motor and the other two have a 15-hp motor. The 10-hp pump was replaced several years ago and had a seal leak at the time of the site visit that was going to be replaced using operating funds. We have provided funds to replace the controls system with the next pump replacement.

Photo 23. Booster pumps

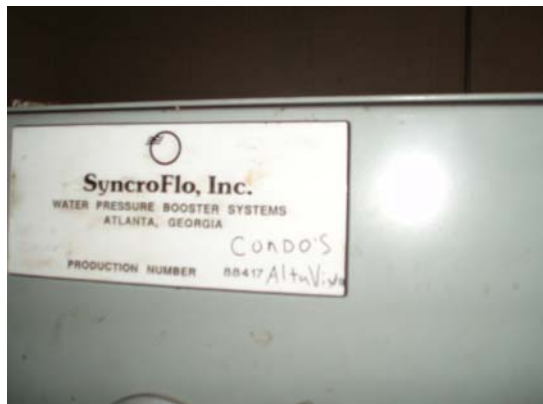
Photo 24. Booster Regulator

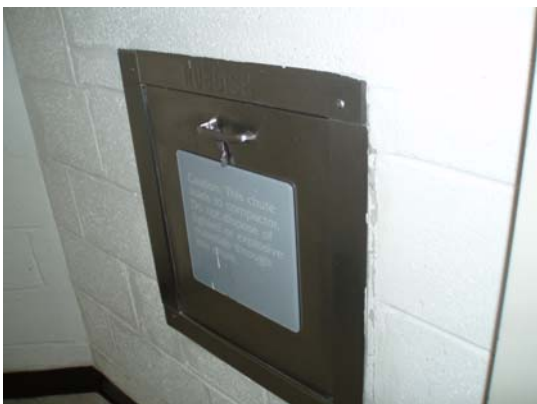
Trash Chutes and Compactor. Trash chutes service each floor in one location above the loading dock area. The trash compactor is used regularly and aging, it is scheduled to be replaced in the next few years. The chute extends from the loading dock to the top floor, with a stainless steel chute door at each of floors 8 - 26. The chute and doors are scheduled to be replaced at the end of a 38-year service life (see photos #29, 30, and 32).

Photo 29. Trash Chute

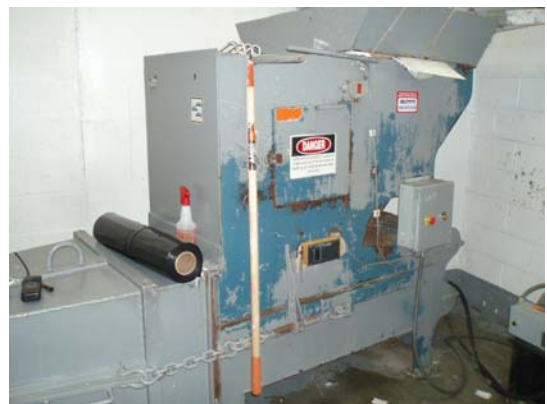
Photo 30. Trash Compactor

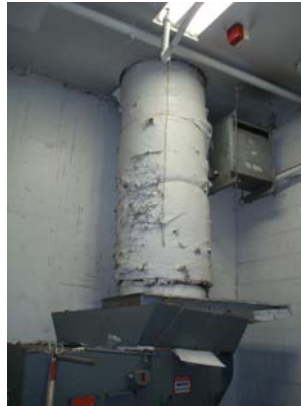
Photo 32. Chute at Compactor

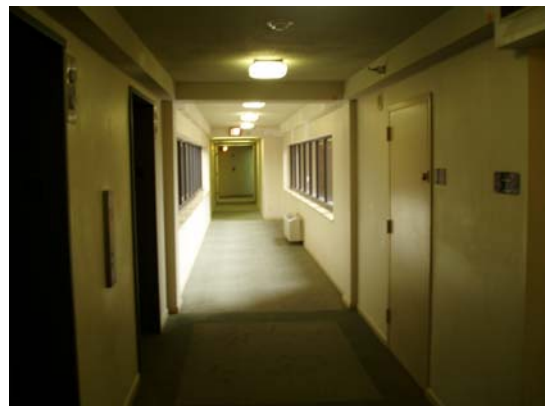
Corridor Renovations. (See photos #42, 43, and 44). The last corridor renovation project is scheduled for 2006. The Association spent \$282,623 painting the walls and ceilings, replacing carpet, and repairing popcorn ceilings throughout the elevator lobbies and corridors. The Association intends to renovate the corridors in similar fashion every 8 years. Light fixtures and ACT ceiling (floors 8 and 26) are scheduled to be replaced every three

Photo 42. Corridor

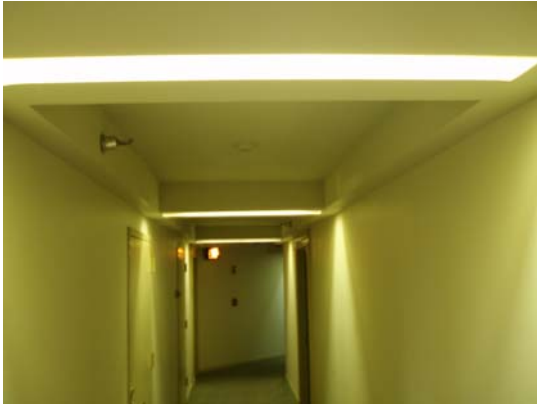
Photo 43. Fluorescent Fixture

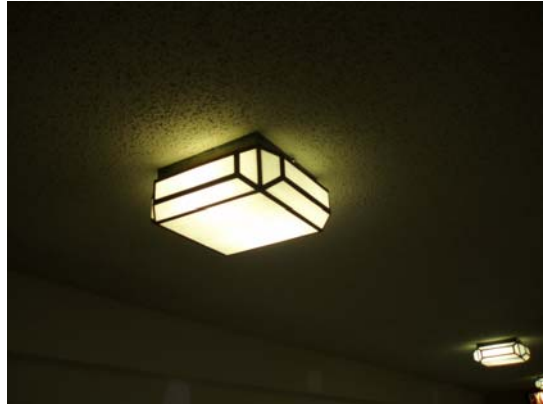
Photo 44. Ceiling Fixture

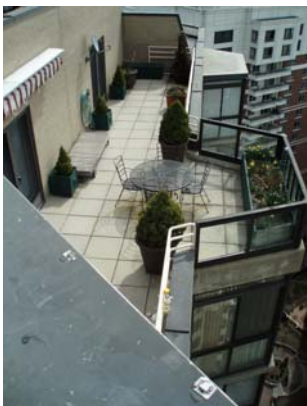
Balconies and Railings. The majority of balconies are enclosed. Three balconies are exposed, and five terraces are open to the weather at the 26th floor. The structure is cast-in-place concrete and should last as long as the building is in service, provided the waterproofing material is maintained and replaced as needed. The terraces have rubber membrane under pavers and two to three drains depending on the size of the terrace. The three exposed balconies and five terraces have metal rail with partial height glass wall integrated with the railing (see photo #47).

Photo 47. Balcony and Railing

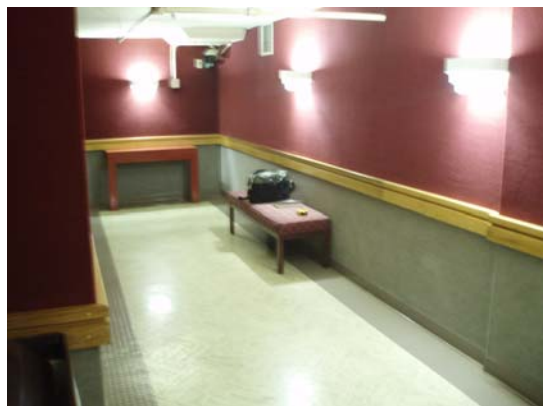
Photo 48. Garage Lobby

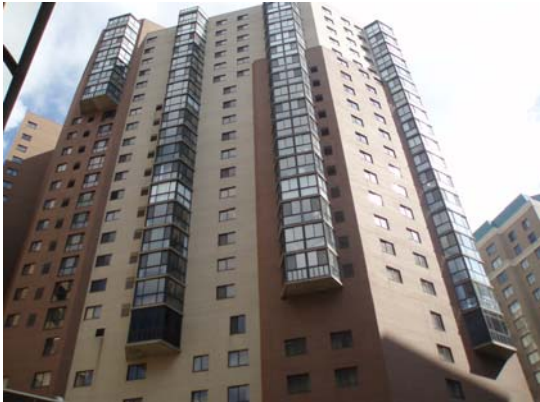
Windows and Doors. (See photo #49). All windows and doors are owned by the Association. The windows are double pane, steel frame, sliding systems except for the pedestrian bridges and balcony enclosures that have fixed windows. The Association has elected to use a special assessment to fund future window replacement with the belief that the windows may never need to be replaced. We have included an allowance of \$200,000 to repair windows every five years, at Legum & Norman's direction. Five terraces are located on the 26th floor and have French doors or sliding glass doors with wood frames. Two terrace doors were recently replaced at a cost of \$6,000 each. Enclosed balcony doors have sliding glass doors with metal frames.

Photo 49. Bay Windows and Windows
