ALTA VISTA
AT BALLSTON METRO CENTER

REPLACEMENT RESERVE STUDY
2007

RE: ALTA VISTA CONDOMINIUM
Replacement Reserve Report

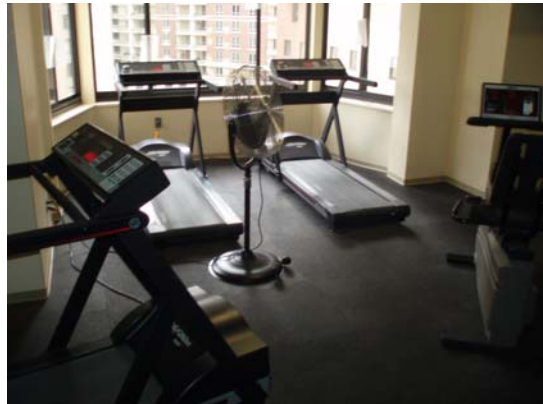
Photo 33. Exercise Room

Health Suite. (See photos #33 and 34). The health suite was moved in 2002 to its present location, and much of the equipment was purchased at that time. The main floor is rubber, and the entrance is carpet. Equipment includes one nautilus machine, one bench, one stair climber, two elliptical machines, two bikes, four treadmills, and one rowing machine.

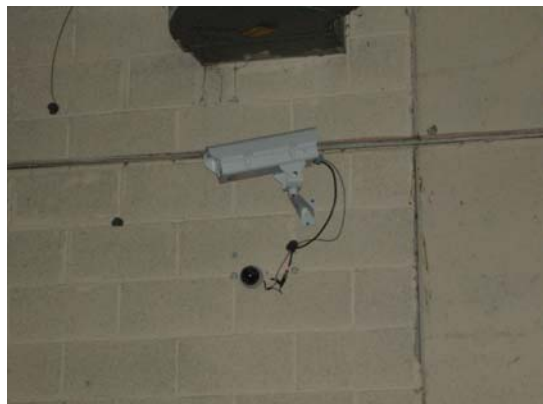
Photo 35. Security

Security / Access Control System. (See photos #35 and 36). Two of the exterior doors are access-controlled. The security system is monitored at the front desk and includes 13 cameras. Several of the cameras in the elevators and other locations are new.

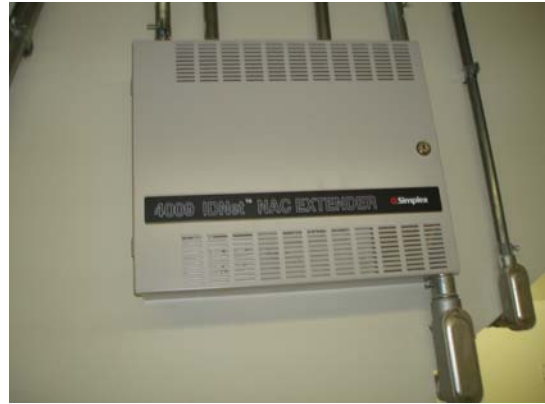
Photo 37. Fire Alarm System

Fire Alarm System. (See photos #37 to 40 and 45). The fire alarm system is Simplex brand. The lobby level Fire Control Room houses the Simplex 4100 main panel, 2120 Command Center, and 4009 IDNAC panel. Eleven other fire alarm panels are located throughout the building. Audible alarms are located in each condominium unit and are owned by the Association (average of two annunciators per unit).
